Listed Buildings

Dinton

Dalwood Farmhouse

Grade II – Listed 17 December, 1986

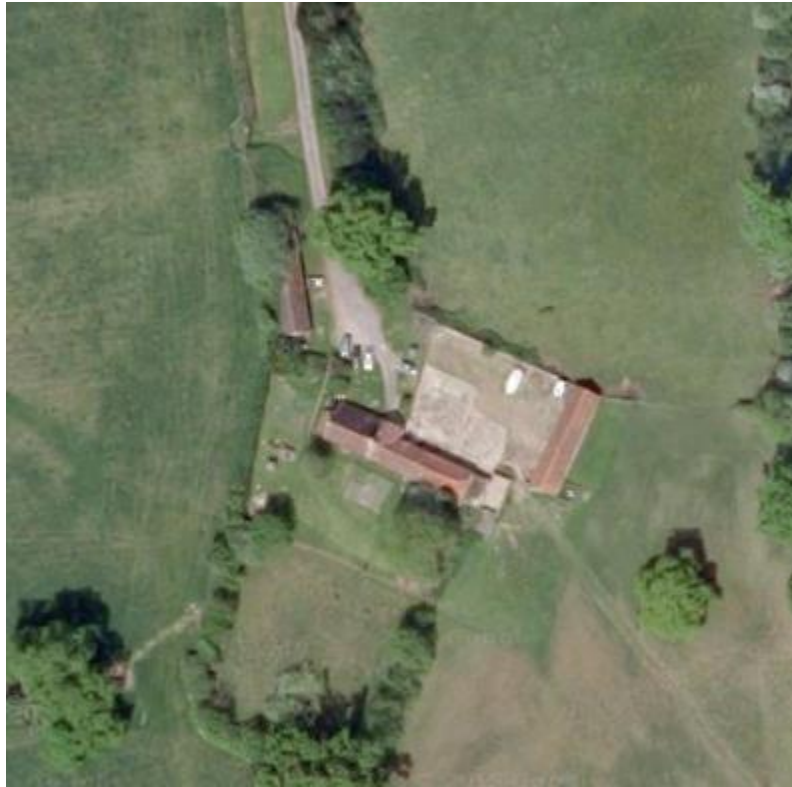
Aerial view of Dalwood Farmhouse

Rubble stone, double Roman tiled roof, coped verges and gable end brick stacks. House with integral outshut on north side. Two-storey, 2-window south front. Central planked door in chamfered case within gabled porch, 3-light casement to right and 2-light casement to left. First floor has two 2-light casements. Rear outshut has two 2-light wood mullioned casements to ground floor. Left return has lean-to extension. Attached to right return is cross wing with planked door and 2-light casements, single-storey outhouses to right with stable doors and half-dormer with 2-light casement.
