Listed Buildings

Dinton

Jesses

Location – Snow Hill, Dinton, Wiltshire

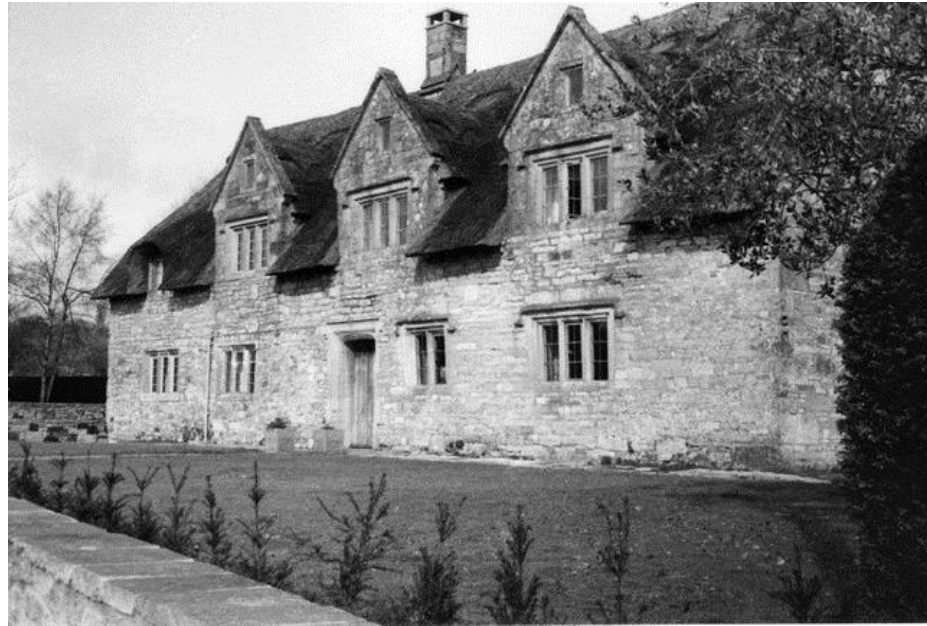
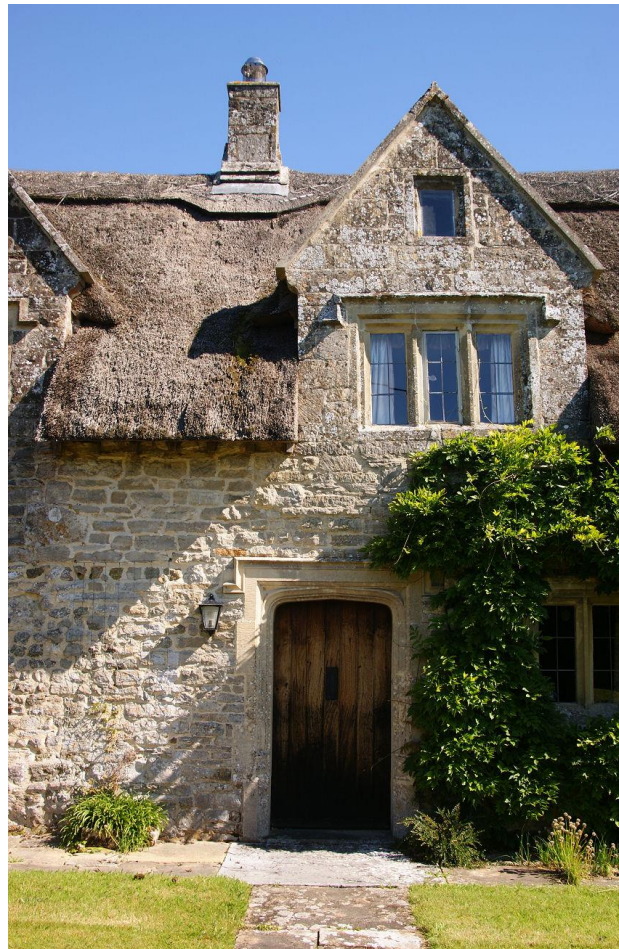
Jesses

Detached house. Early C17, altered 1930s.

Rubble stone, thatched roof with half-hip to left and stone stacks with moulded cappings. Three-cell with entrance into hall at rear of stack. Single-storey and attic, 4 windows. C20 Tudor-arched doorway to centre with 3-light hollow-chamfered mullioned casements to left and 2-light and 3-light mullioned casements with hoodmoulds to right. Attic has three full gabled dormers with 3-light hollow-chamfered mullioned casements under single casements; the left one 1930s addition, 3-light C20 casement to eyebrow dormer to left. Left return has 4-light C20 casement and 3-light mullioned casement to ground floor, two 3-light casements to eyebrow dormers. Right return has mullioned casements and C20 door, wing to right is 1930s addition in C17 style. Rear has added outshut to main range with gabled dormer and gabled stair turret with C20 mullioned and transomed window, wing to right has C20 casements.

(Both Photos taken by Andrew Stacey – above in 1963 & below taken 2011)

Interior has deep chamfered beams with stepped stops, hall has reset wainscot panelled dado, west drawing room has Tudor-arched stone fireplace set within open fireplace with deep chamfered lintel, wood mullioned window retained in former rear external wall, now within passage, east room has open fireplace with chamfered lintel on stone jambs.

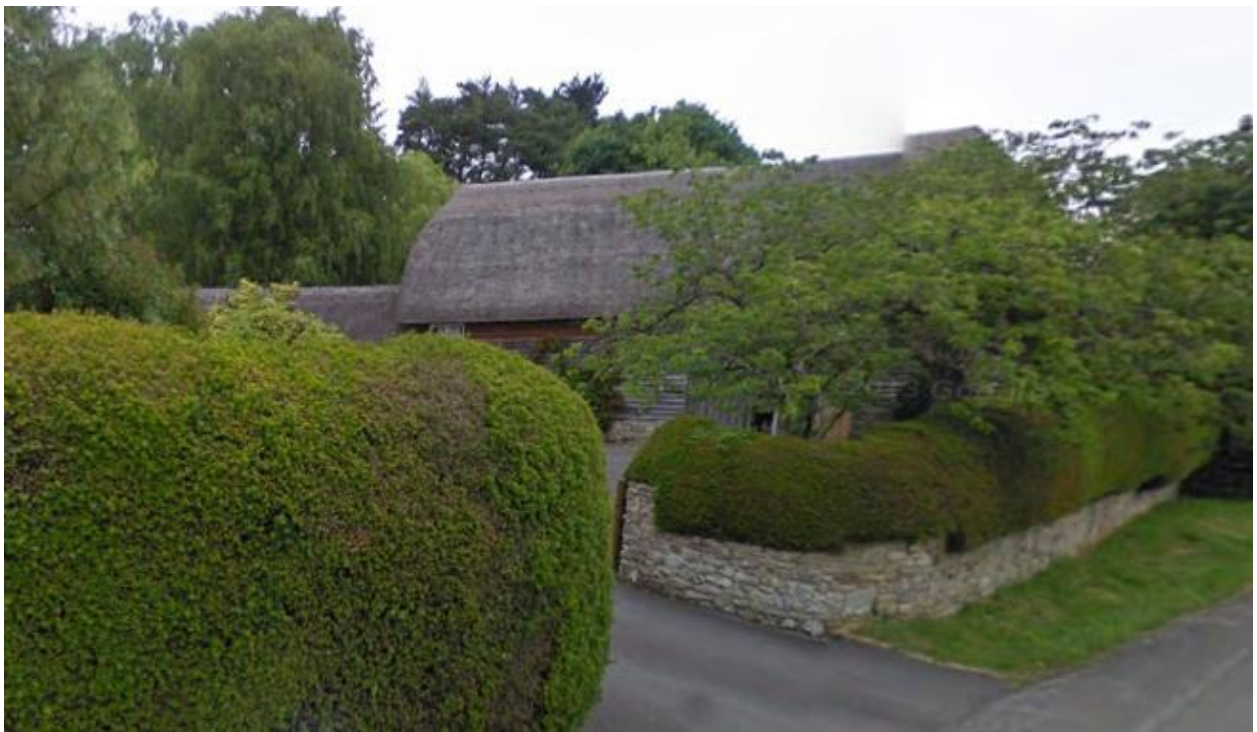
Barn and Sheltershed at Jesses

Barn and former shelter shed. C18.

Timber-framing clad with weatherboarding, thatched roof with half-hips. Four-bay barn, five-bay shelter shed attached to left. Barn has double planked doors to right and C20 planked garage doors to left with 6-pane fixed window over. Shelter shed has 2-light casement to right, planked doors, formerly open-fronted and now partially boarded.

Interior of barn partly subdivided to provide garaging in left bay, tie-beam roof with raking struts to principals and C20 inserted scissor braces from floor to principals.
