Listed Buildings/ Monuments

Old Manor House

Location – 60 Duck Street, Sutton Veny, Wiltshire

Grade II* - Listed 11 September, 1968

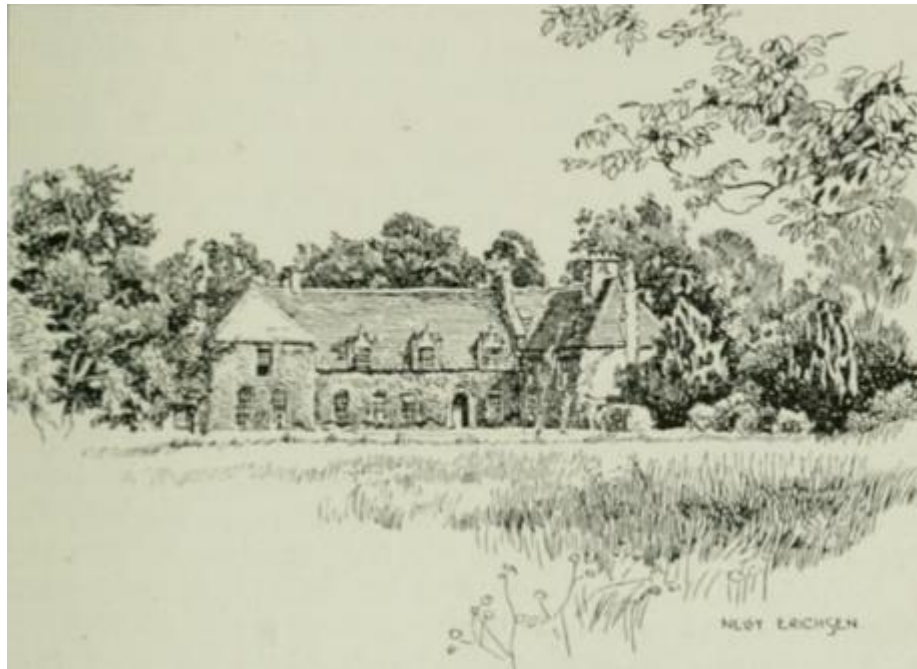
The Old Manor House, Sutton Veny

(Illustration by Nelly Erichsen from Highways and Byways in Wiltshire by Edward Hutton-1917)
